NASA Technical Memorandum 85654

STRUCTURAL RESPONSE OF TRANSPORT AIRPLANES IN CRASH SITUATIONS

R. G. THOMSON AND C. CAIAFA

JUNE 1983

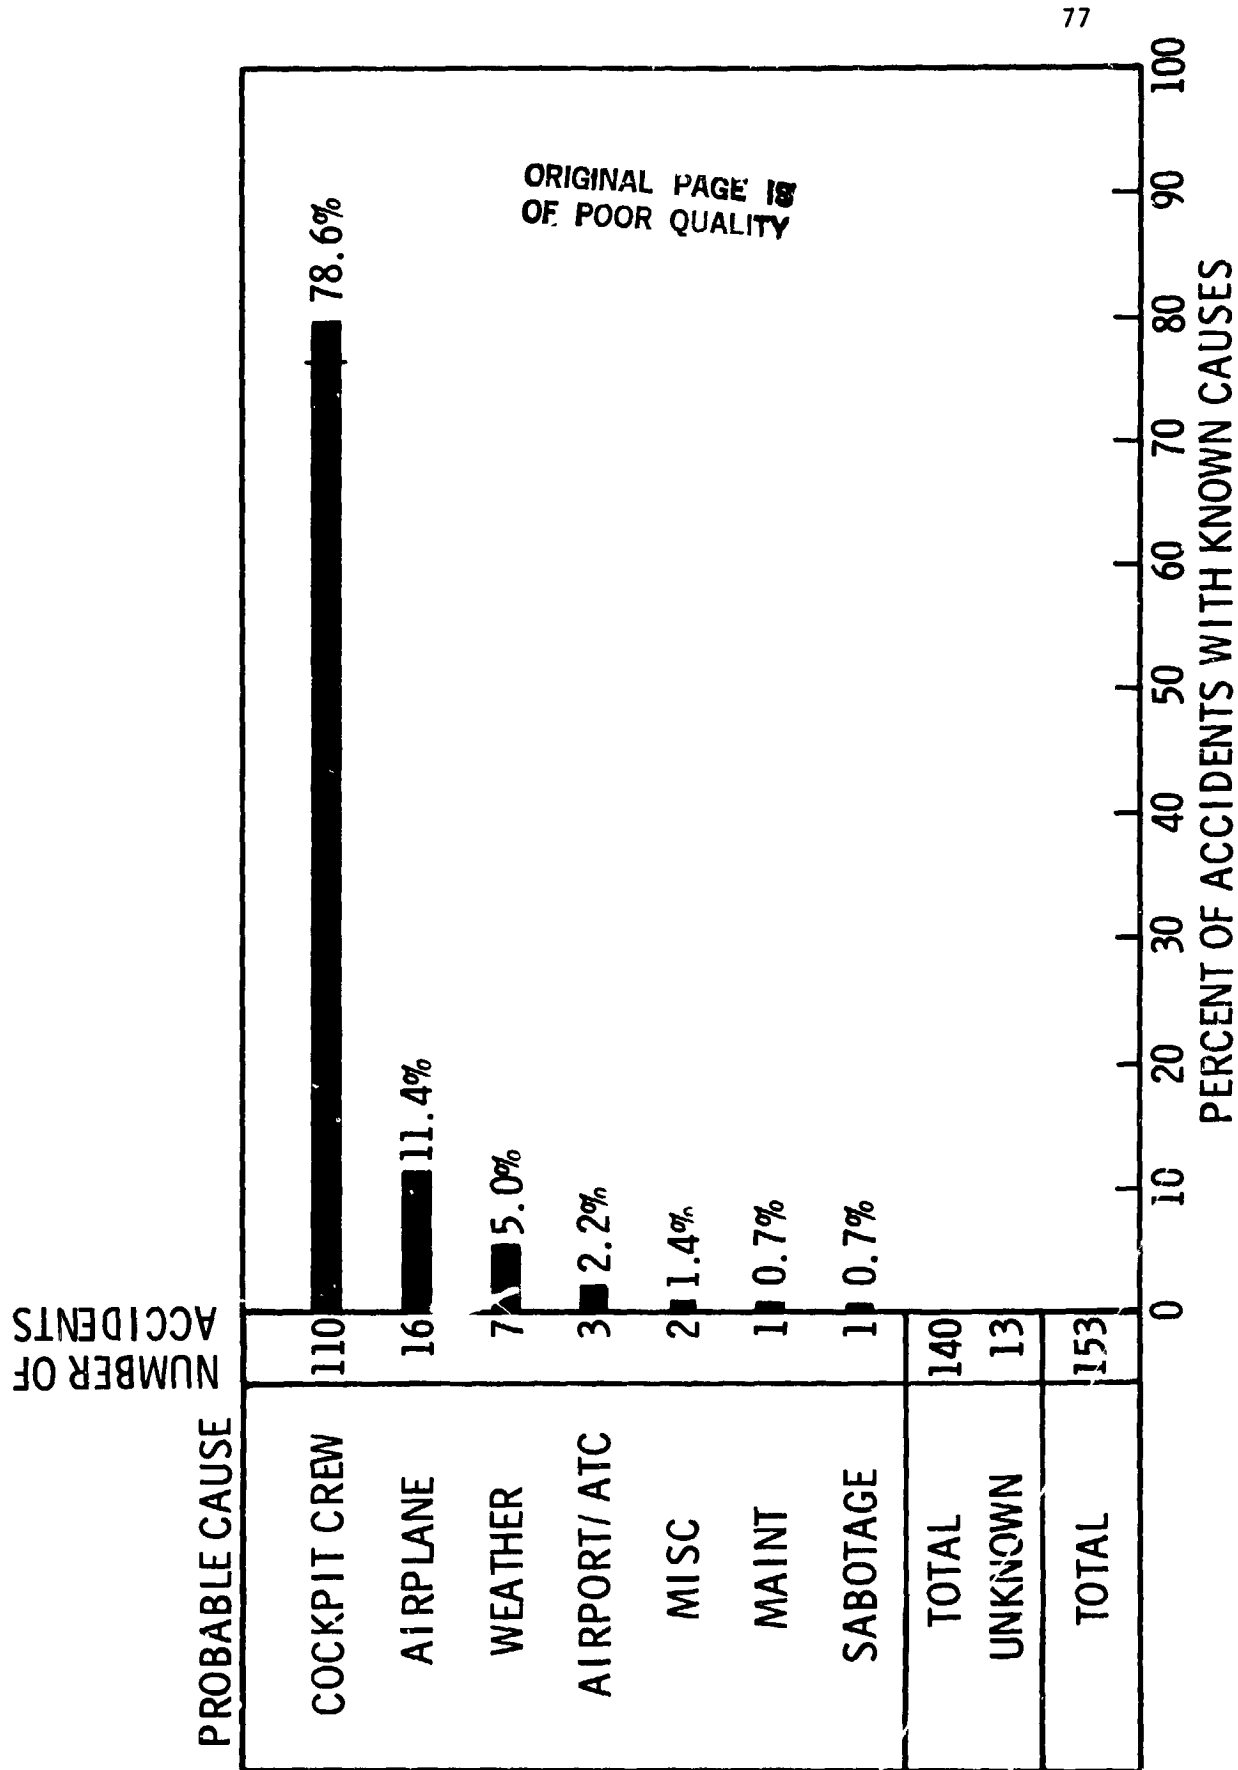
FIGURE 7. - PROBABLE CAUSE OF ACCIDENTS

The probable cause of accidents is presented in figure 7 (ref. 19). "Probable cause" is based on the determination of the accident investigation team. For 13 accidents the cause is unknown. For 140 cases where cause has been determined 76.4% of the cases are attributed to the cockpit crew, 11.1% to the airplane, 5% to weather, 2.1% to the airport/air traffic controller, 1.4% to miscellaneous, 0.7% to maintenance, and 0.7% to sabotage.

The aircraft was the cause of the accident in 11% of the cases. Landing gear systems and support structure were involved in 7 accidents. Failures involved brakes, wheels, tires, and structure. Engine disintegration, thrust loss, and thrust reversers were involved in 6 accidents. Flight instrumentation was involved in 2 accidents and ground spoilers and elevator trim tab were each involved in 1 accident. From these data it may be concluded that a large percentage of the accidents can be attributed to human error such as pilot and ground control assistance. Such items as ground proximity warning, wind shear detection, automated landing and navigation systems, and advanced integrated systems for pilot assistance offer the best hope for eliminating most accidents in the "avoidable" category. Improved ground control and reduction of hazards on and around airports is another area for improved safety. The avoidance of collisions between aircraft and with ground vehicles should be attainable. Reduction of hazards such as drainage ditches, poles, trees, columns, outbuildings and birds from airports is a matter of concern. In addition the overrun areas for runways could be improved to reduce the severity of accidents in these areas.

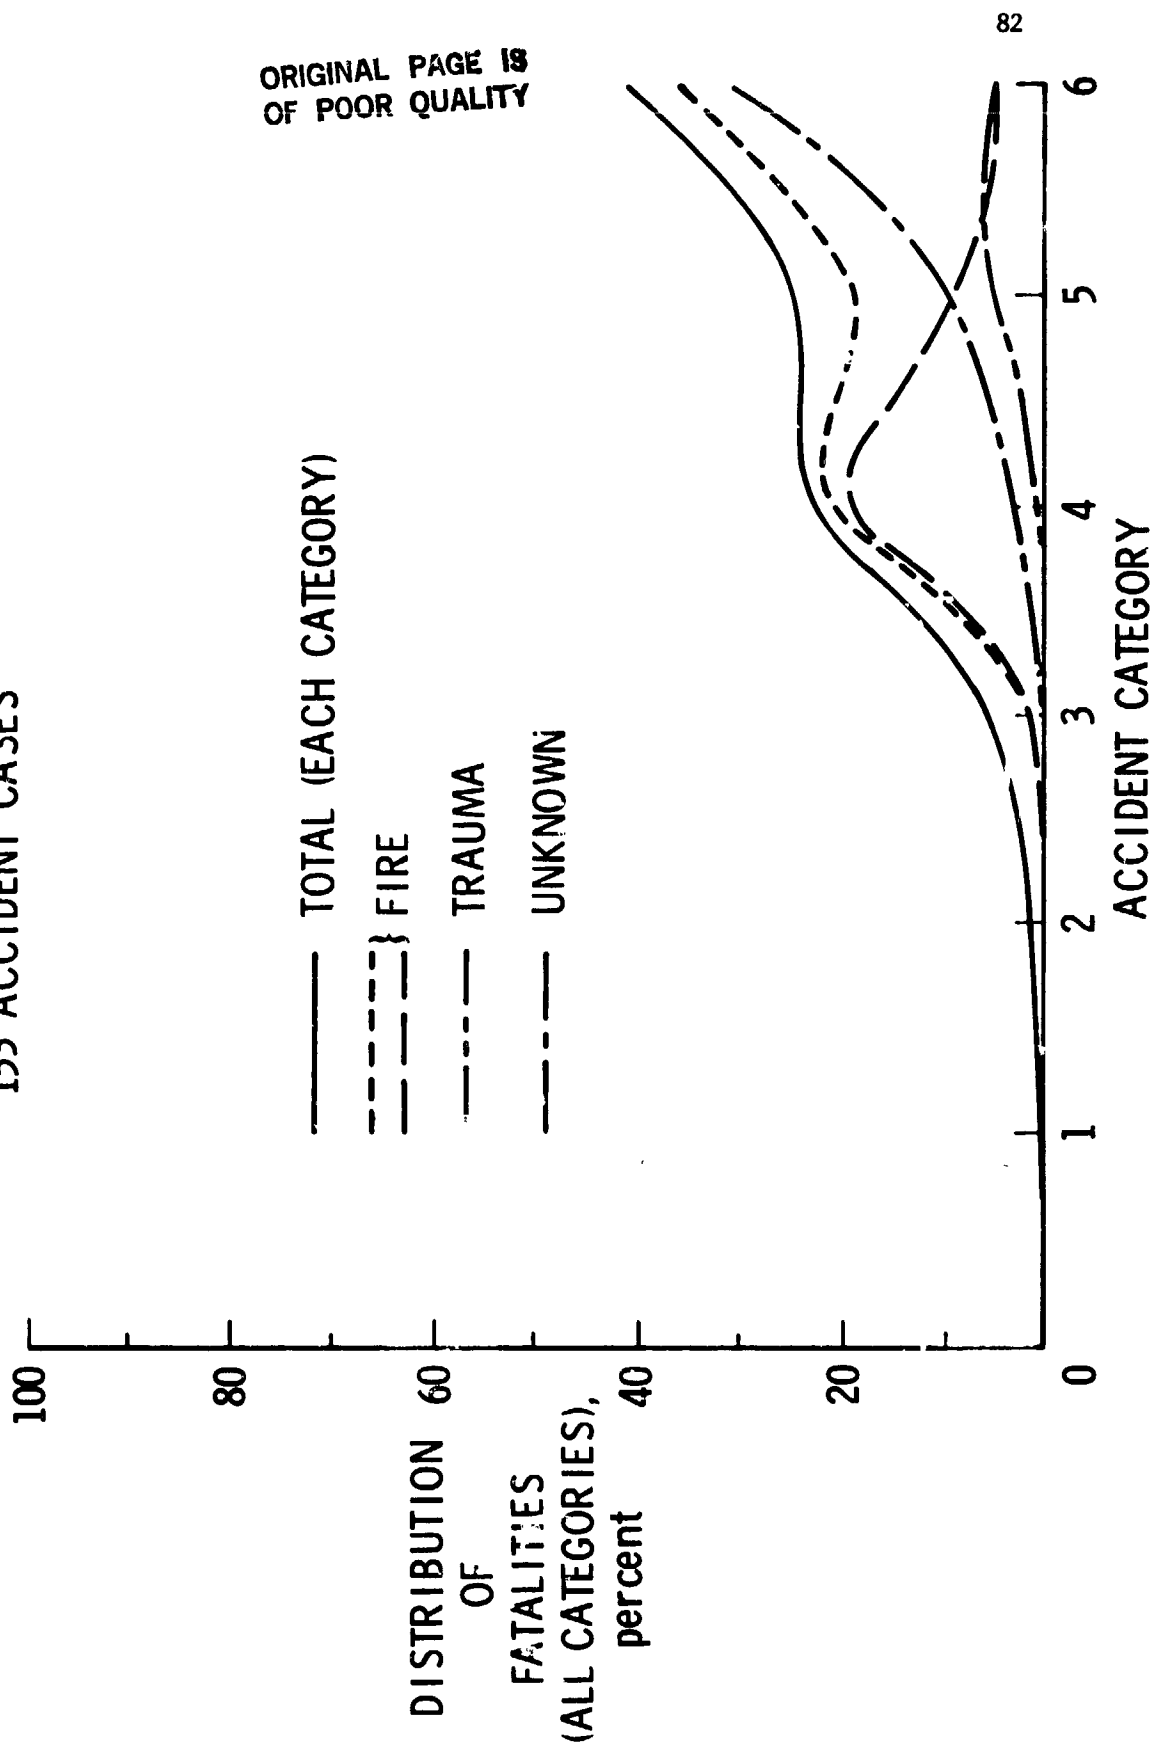
FIGURE 10. - DISTRIBUTION OF FATALITIES AS A FUNCTION OF ACCIDENT CATEGORY

The 153 well-documented accidents in the data base have been grouped by category and are summarized in table 12 and figure 10, from which some general observations may be made. First as regards overall survivability, fire presents the greatest hazard. Known fire fatalities outnumber known trauma fatalities by 2.8:1. (This is in contrast to the results presented in figure 8(b) for domestic accident data only.) The foreign accident data reflects the same fire to trauma fatality ratio (approximately) as given here. Fire hazard is most severe for accidents having major fuel spills due to rupturing of fuel tankage (categories 4, 5, and 6). Trauma fatalities occur mostly in categories 5 and 6 which involve severe fuselage breaks. Little structural or detailed information is available on several accidents in which a large percentage of the occupants perished. Deep water impact accidents represent less than 10% of the study data base. Water impact usually results in severe damage to the lower fuselage, often accompanied by class 2 breaks in the fuselage and separation of wings, engines, and landing gear. In some cases many occupants drowned after evacuating the aircraft. In other cases the high fatality rate was due to inappropriate action of the cabin crews after the aircraft came to rest.

Last, as might have been anticipated, the overall survivability generally decreases as the major structural damage to the aircraft increases. For categories 5 and 6, known fatalities due to fire and to trauma appear in almost equal numbers. These categories also have the largest percentages of undefined fatalities. The dashed line in figure 10 is an extension of the fire fatalities curve if one adds all of the undefined fatalities to the fire fatalities.

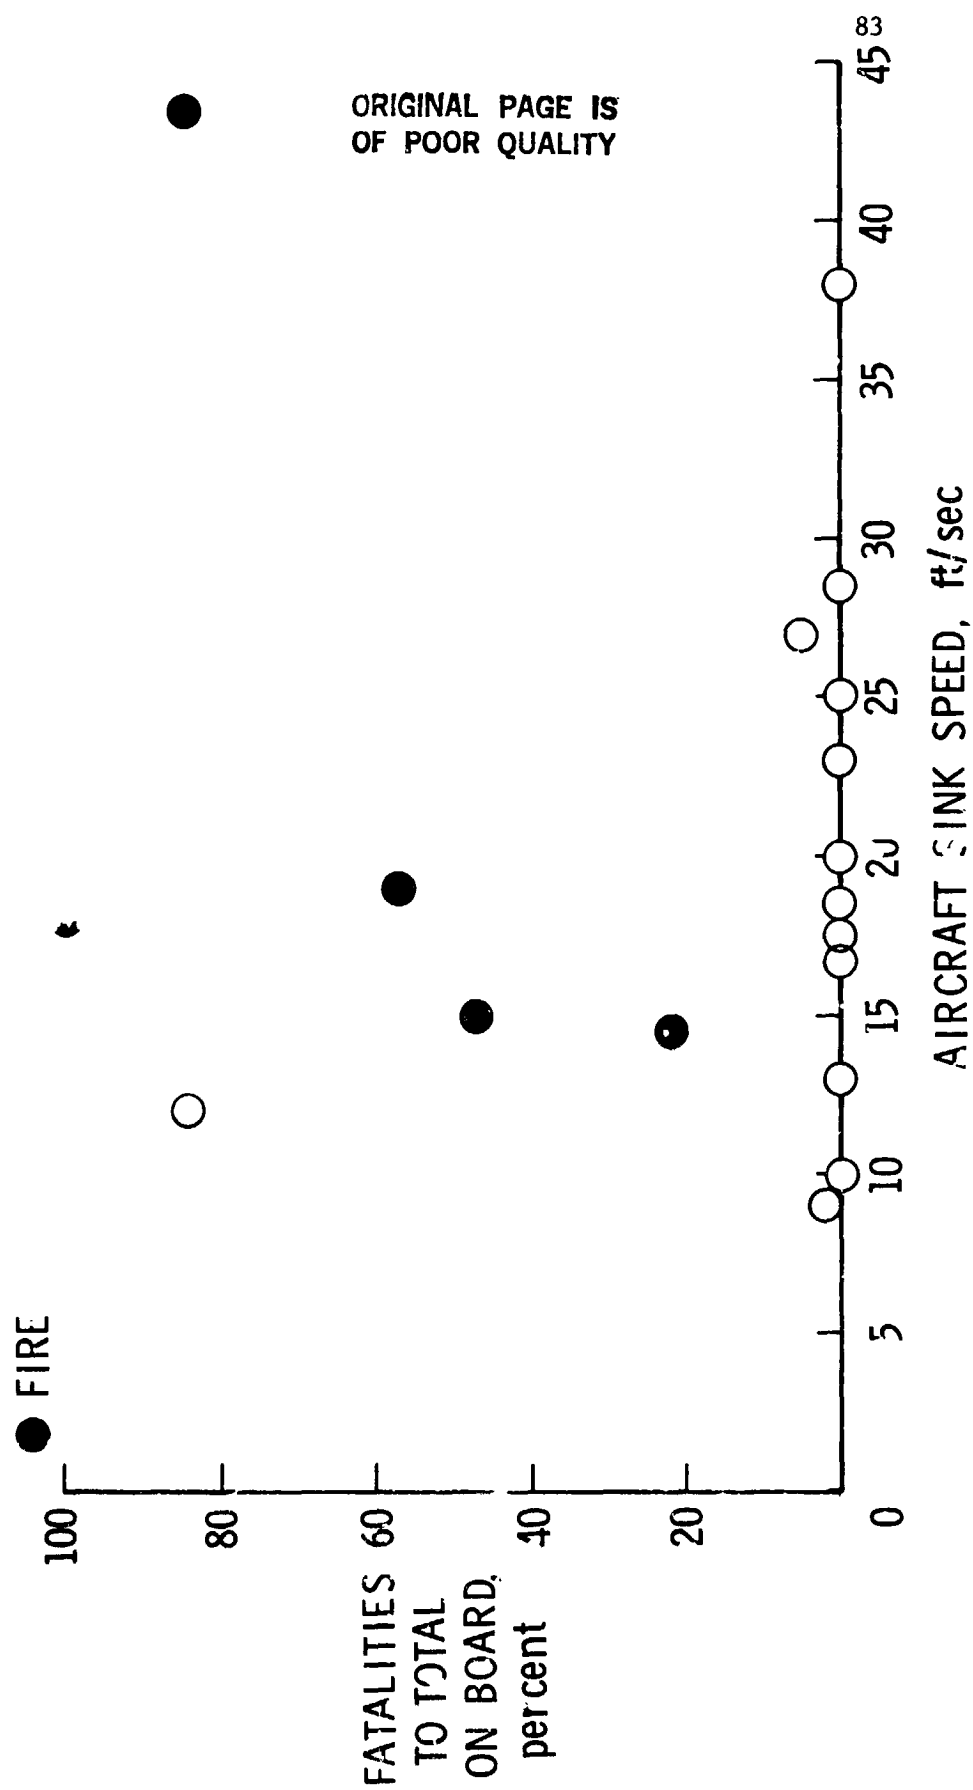
FIGURE 11(A). - FATALITIES AS A FUNCTION OF SINK RATE; REF. 19

To further explore the effect of rate of descent on fatalities a graph of fatalities as a percentage of total onboard for air-to-surface approach accidents, as a function of sink rate, is plotted in figure 11. In figure 11(a) the data from ref. 19 is presented, in 11(b) the data from ref. 20, and in figure 11(c) the data from ref. 21. Recognizing the fact that following initial impact, subsequent hazards may be encountered such as impact into columns, ditches or other obstructions the data plotted in figure 11 should only be viewed as indicating a trend. Furthermore, the accidents in which a large percentage of the fatalities are fire related are shown as solid symbols. Reviewing the solid and open symbol data for all three data bases indicates a general increase in trauma-related fatalities occurring at aircraft sink speeds of approximately 25 fps and above. This trend shows an inherent structural capability of the airframe to provide a good measure of load attenuation in the vertical direction. In figure 12(a), (b), (c) the percent injury to total onboard is plotted as a function of sink rate for the same air-to-surface approach accidents as in figure 11. Again, the accidents involving a high percentage of fire-related fatalities are shown as solid symbols. The data exhibit no apparent trend indicating that injury-causing mechanisms may be more local in nature than global. The accident data does show injuries occurring at a sink speed of 10 fps and above which coincidentally is approximately the landing gear design sink speed.

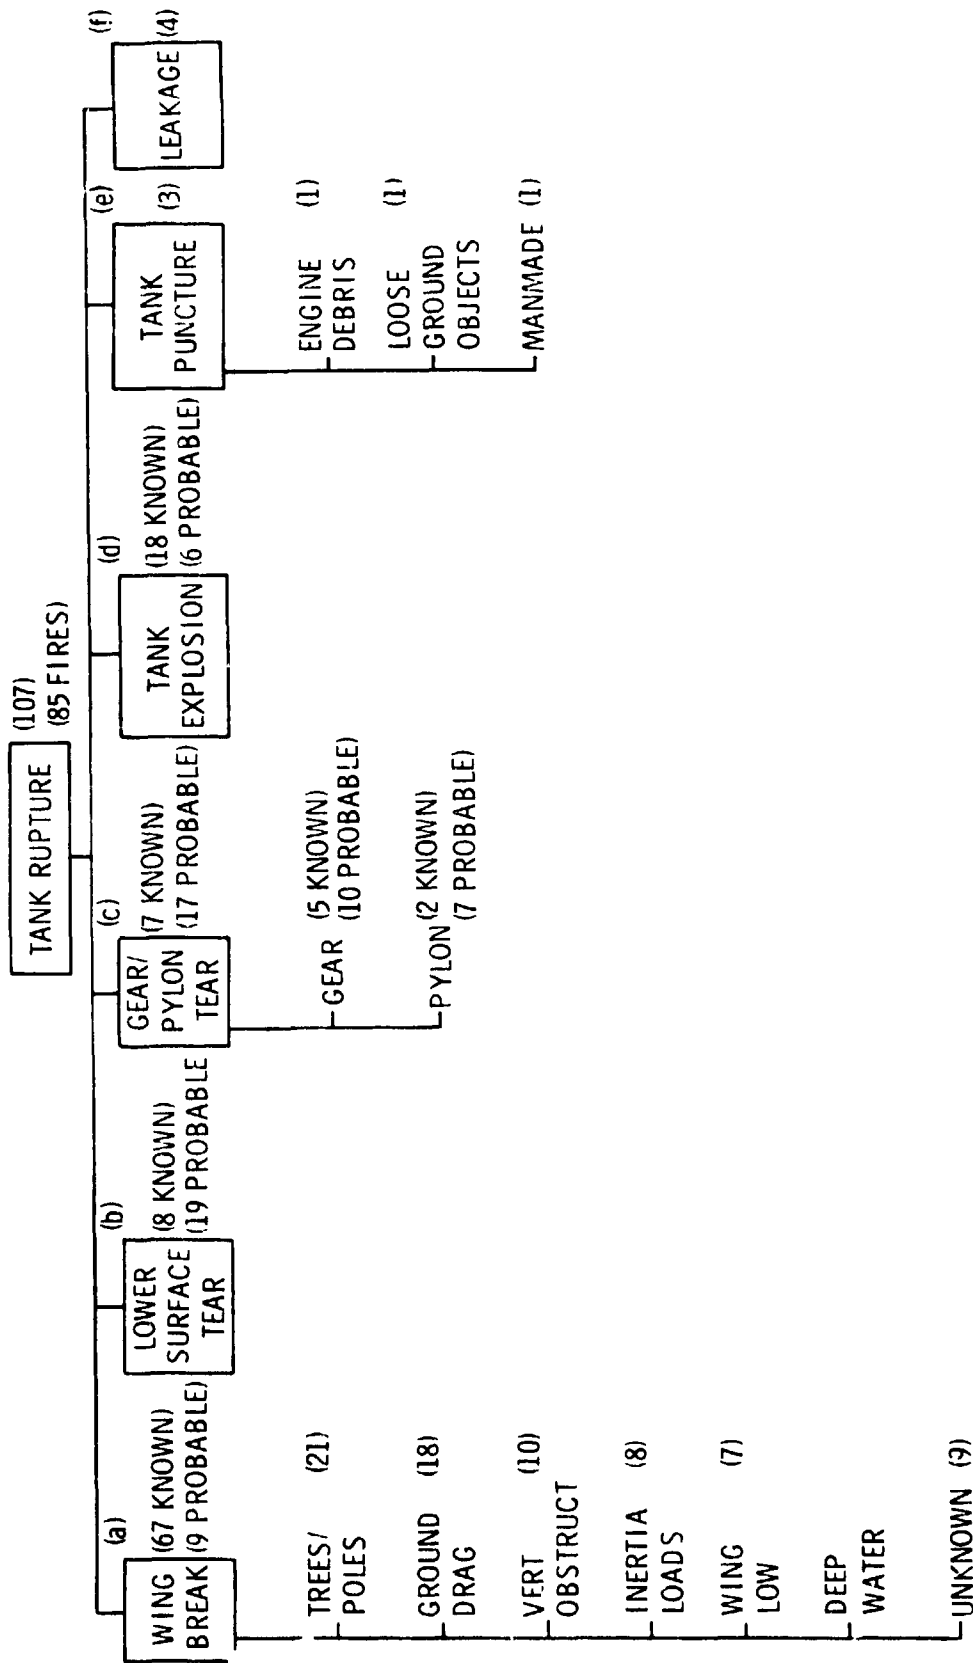
FIGURE A1. - TYPES OF TANK RUPTURE (REF. 19)

(a) Main landing gear collapse or separation allows the wing box to scrub on the runway or terrain and to impact low objects or allow engine pods to scrub and separate. Main landing gear design that is more resistant to collapse or separation due to hard landings or travel over rough/soft terrain would be effective in reducing the number of fire related accidents (table 16) in which tear or rupture of the wing lower surface has occurred.

(b) Engine separation and tumbling under the wing has caused rupture or puncture in the wing box. Engine to strut or strut to wing design should be developed to reduce probability of separation.
